NASA CR-196566

**BSM DELTA QUALIFICATION 2  
FINAL REPORT**

**UNITED  
TECHNOLOGIES  
CHEMICAL  
SYSTEMS**

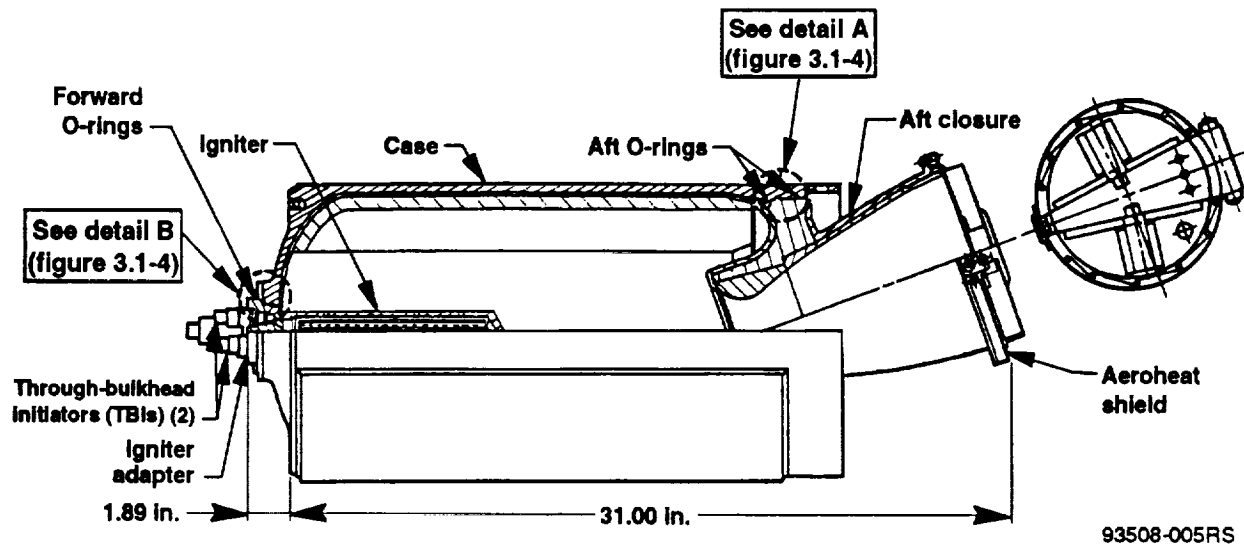
**Figure 3-1.1. BSM Design Changes/Enhancements**

**3.1 TEST CONFIGURATIONS.** The enhancements noted in figure 3.1-1 are the changes to the BSM that have been validated by the adhesive qualification test program and the vulcanization test program for certification through the Delta Qualification 2 testing program. Figures 3.1-2 through 3.1-5 identify the configurations of the forward and aft motors and motor system components which were tested to provide the data used to establish qualification of the modified BSM. Figure 3.1-2 shows the forward motor assembly and figure 3.1-3 shows the aft motor. Both motor configurations were subjected to thermal cycling at CSD, vibration and shock testing at MSFC, and static testing at CSD as described in subsequent sections of this report. Each motor was subjected to the environmental shock and vibration testing with an aeroheat shield attached to simulate the nozzle exit cone mass distribution experienced in an actual SRB functioning. Figure 3.1-4 provides a detailed description of the forward/aft motor igniter adapter area design change/enhancements incorporated into these two motors. Figure 3.1-5 provides a detailed description of the motor aft end design change enhancements.

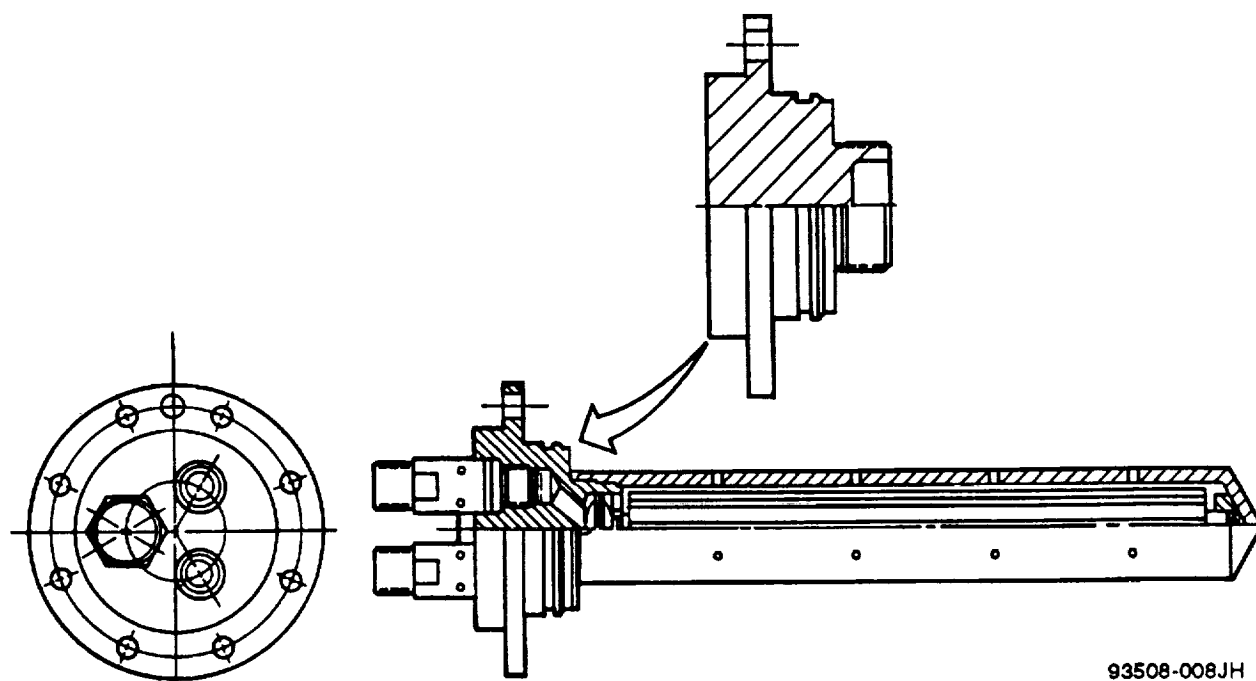
### Figure 3.1-4. BSM No RTV Configuration

**RTV omitted**

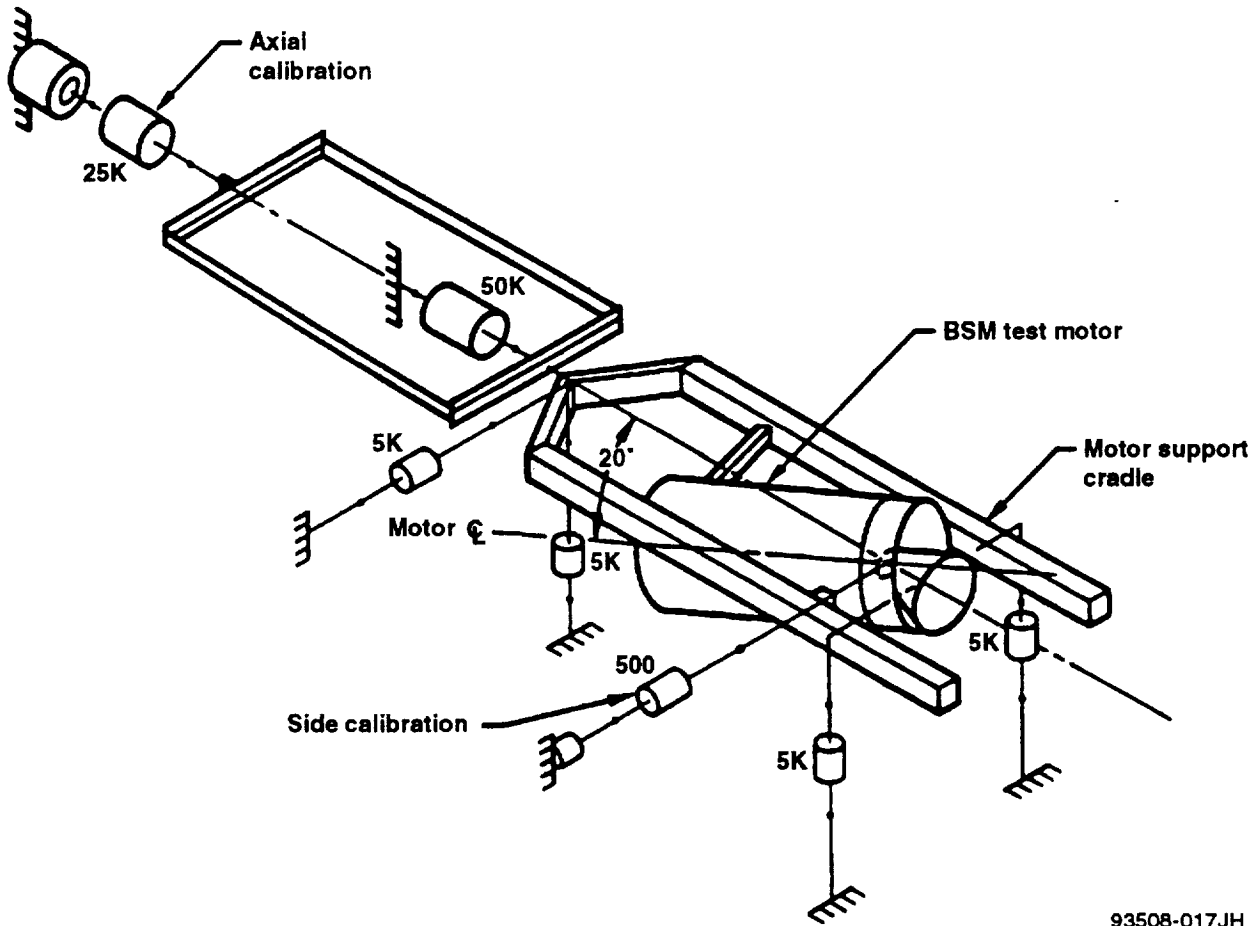
Figure 5-1. BSM Six-Component Test Stand Schematic

Motor temperature conditioning was accomplished by preconditioning the motors to the specified conditions for a minimum of 24 hr, then transferring the motor to the test stand and completing static testing within the time period required to ensure that the motors were at the desired mean bulk grain temperature at time of test.

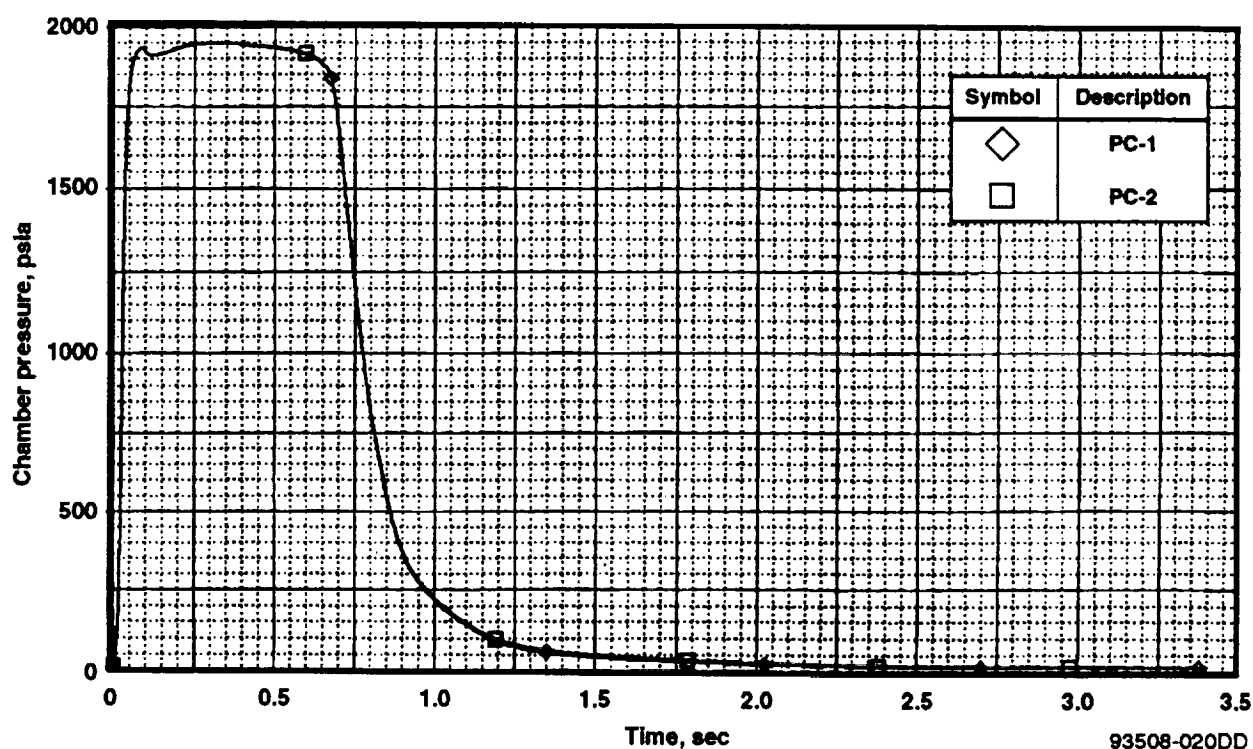
**Figure 5.2-1. Delta Qualification 2 Motor Performance Summary**

**5.2.1 Motor Performance by Analysis.** The motor performance results based on engineering analysis of the two Delta Qualification motors are summarized in figure 5.2-1. As shown, both motors demonstrated compliance with the specification requirements, even for the intentional "overtest" conditions achieved.

The comparative evaluations, which were conducted for each of the motor performance parameters identified in figure 5.2-1, are discussed in the following subsections.

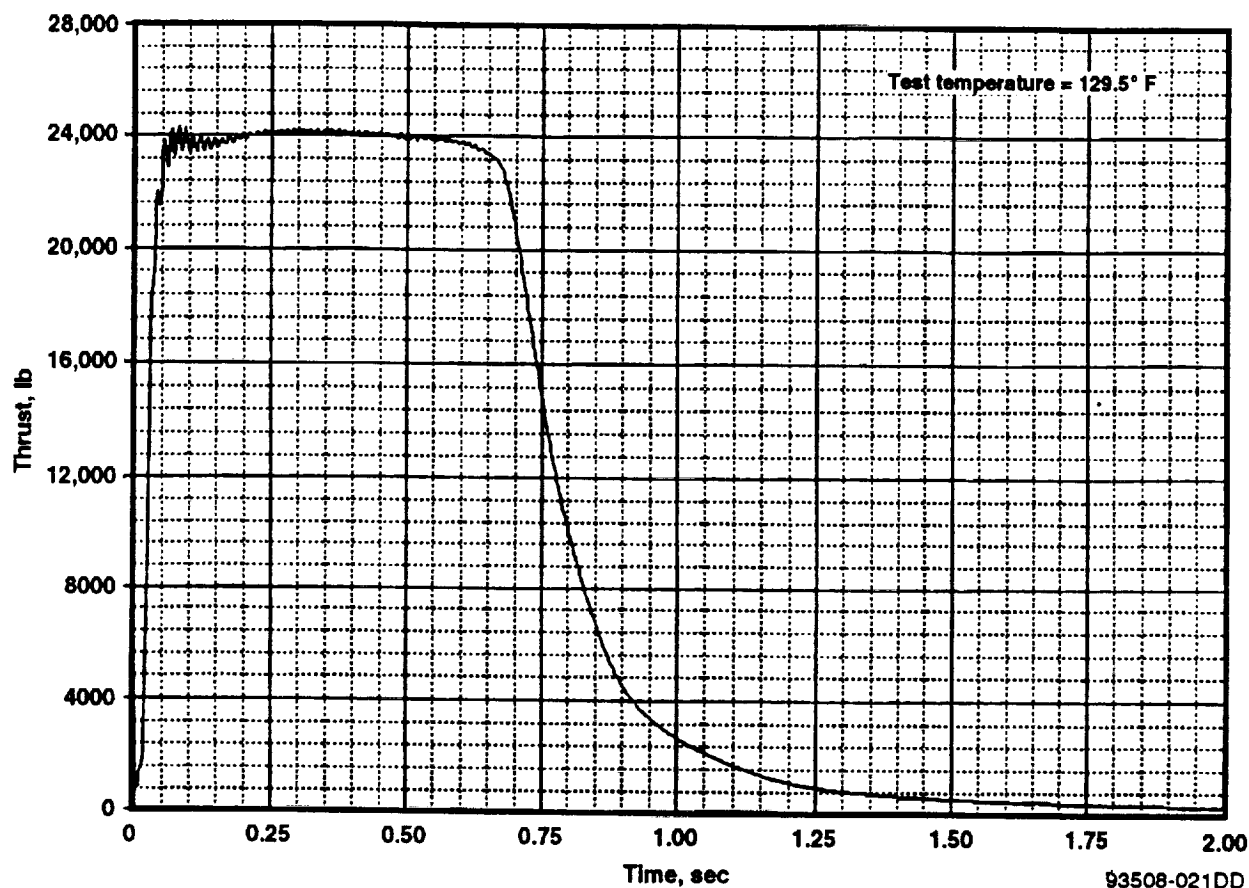
**Figure 5.2-2. Chamber Pressure vs Time, Motor S/N 1000738**

Figures 5.2-2 through 5.2-5 present detailed plots of pressure versus time and axial thrust versus time for both Delta Qualification motors. As noted in the review of this data, both motors exhibited satisfactory ballistics with no anomalies evident in either the pressure or thrust data.

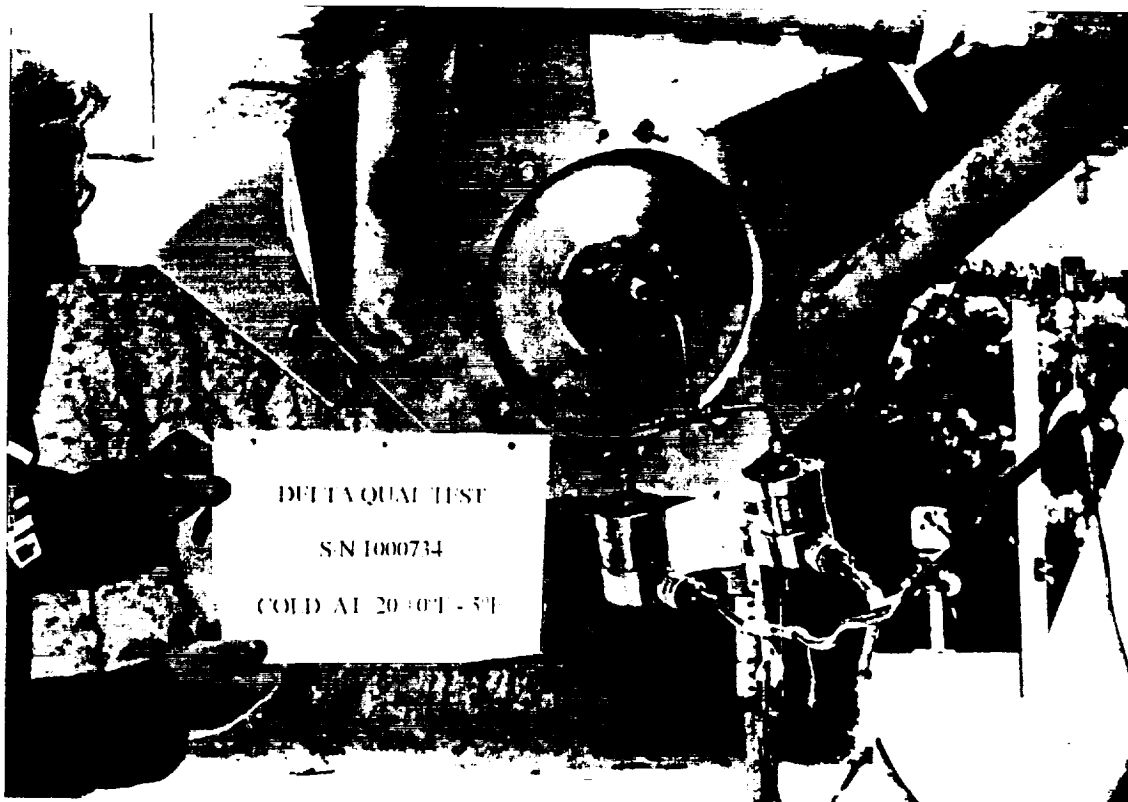
**Figure 6.1-1. Motor S/N 1000734 (22.2°F), Pretest Forward View**

**6.1.1 Motor S/N 1000734, Test Temperature 22.2°F.** Figures 6.1-1 and 6.1-2 show forward and aft pretest views of motor S/N 1000734 (22.2°F). Figure 6.1-3 shows a pretest side view of the same motor. This photograph was taken prior to motor installation into the test stand for clarity of the motor view.

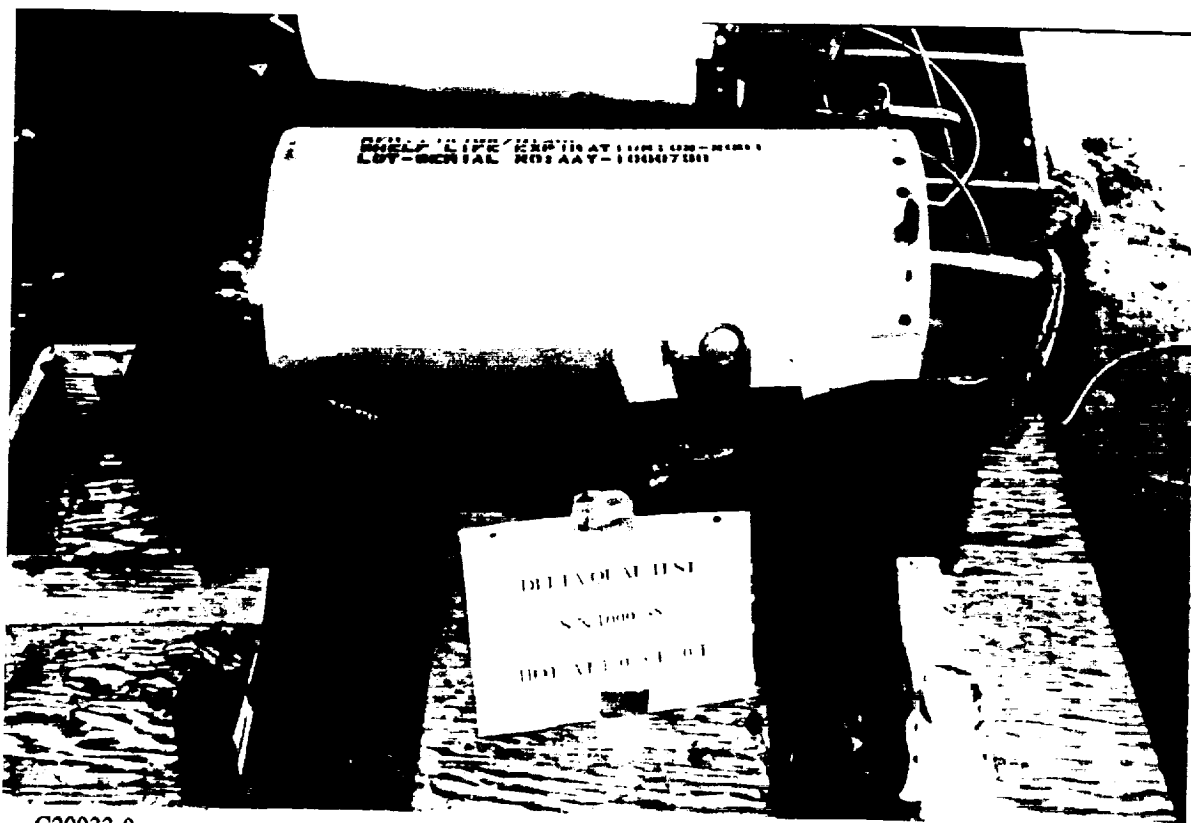
C20933-9

**Figure 6.1-10. Motor S/N 1000738 (129.5°F), Pretest Side View**

This motor was also found, in conjunction with the motor performance analyses discussed in Section 5, to have provided the proper test bed for assessing the enhancements addressed in subsections 6.3 through 6.8 of this report.

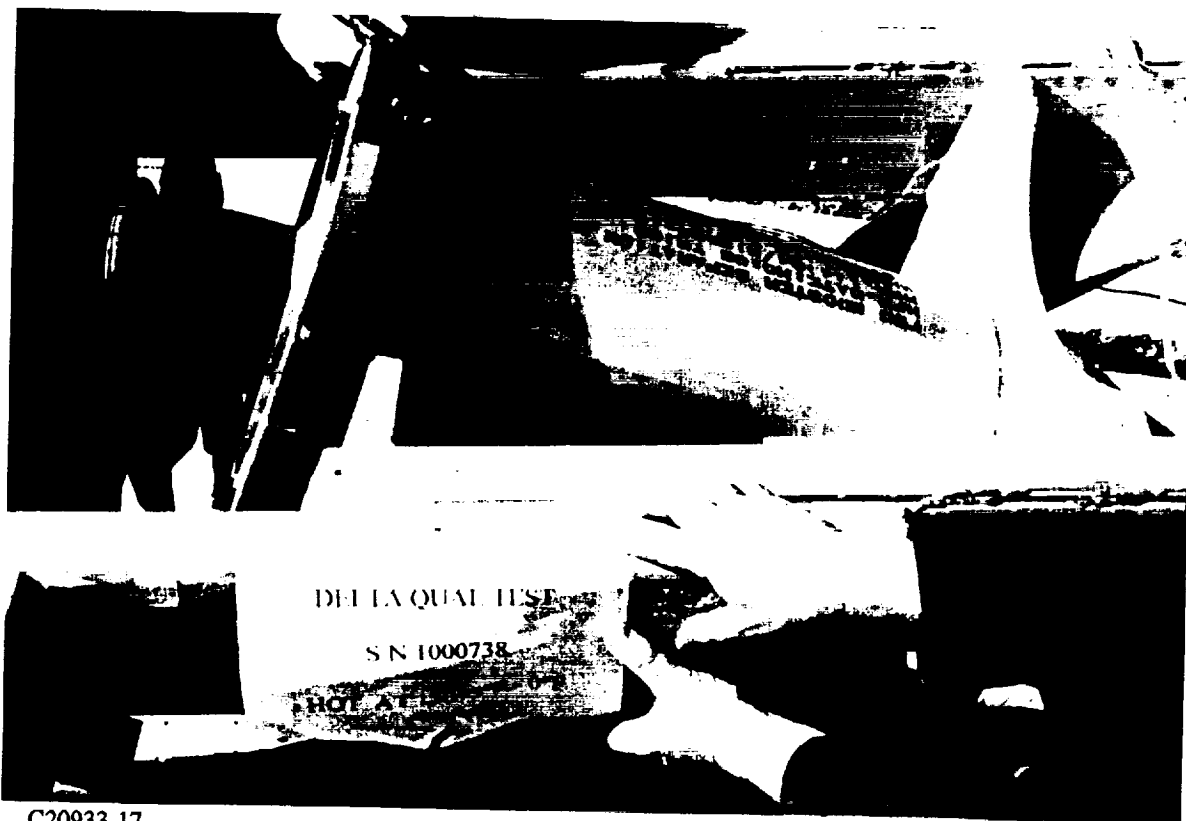
C20933-17

**Figure 6.1-14. Motor S/N 1000738 (129.5°F), Posttest Side View**

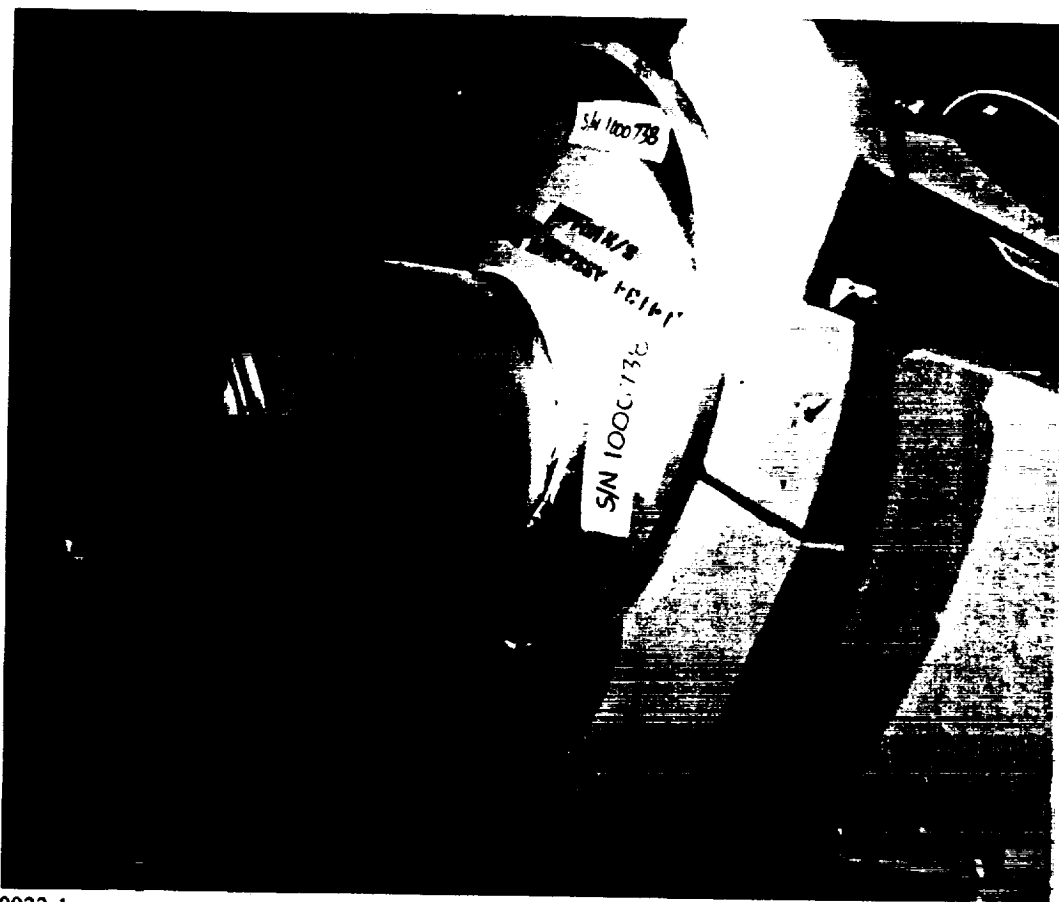
C20933-1

The clearance between the motor case O-ring sealing surface and the nozzle closure insulation OD and the forward nozzle closure lip when installed in a motor case intentionally form the small annular entrance area for the combustion gases to fill or "charge" the nozzle closure primary O-ring. This area is open for the 360° circumference, which allows the combustion gases to uniformly charge the O-ring and minimizes circumferential flow in the O-ring groove (see Reference 2).

**Figure 6.1-15. Motor S/N 1000738 (129.5°F), Posttest View of Nozzle/Closure Interface**

Even for this overtest condition, however, the O-ring erosion is consistent with the test condition and within the database.

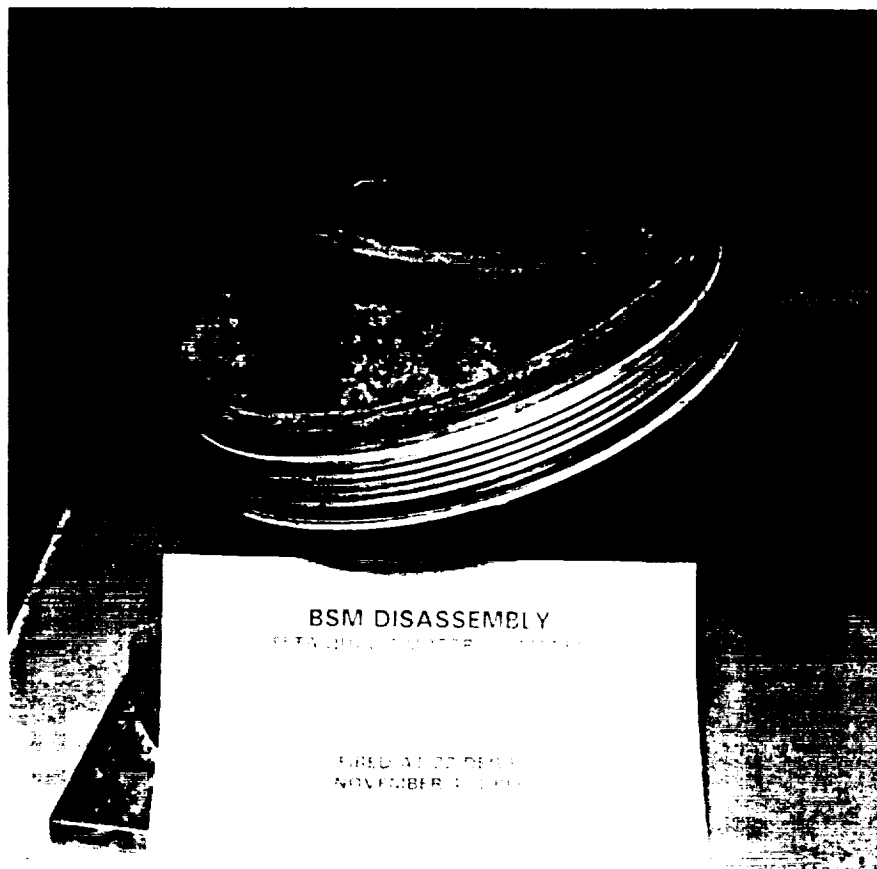
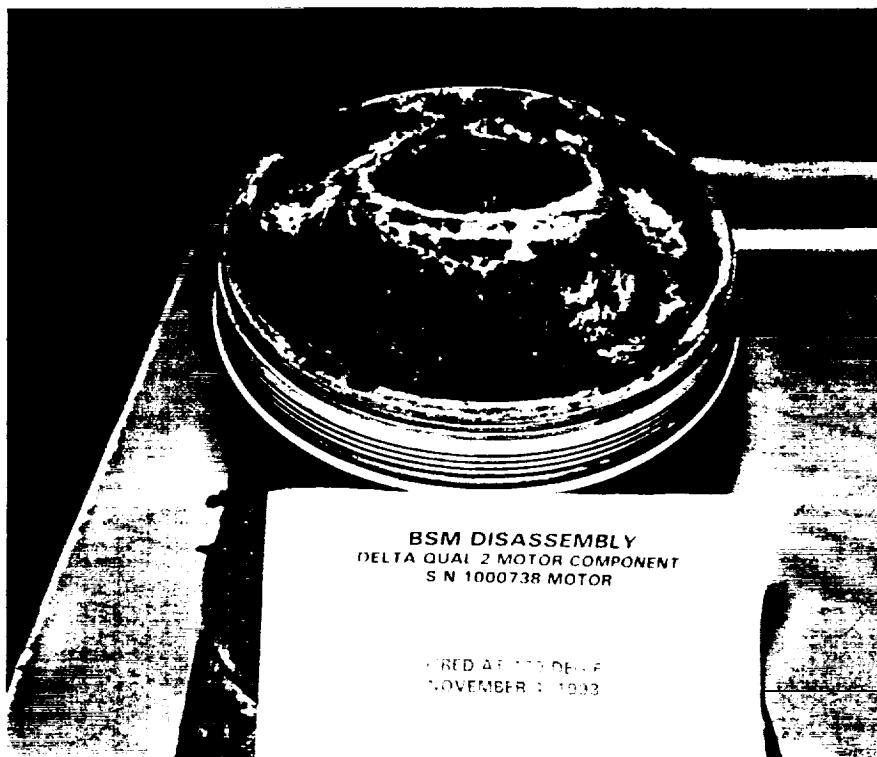
**Figure 6.3-4. Vulcanized Insulated Aft Closure, Motor S/N 1000734 (22.2°F), Posttest**

Both closures were in excellent condition. Visual inspection showed the insulators to be bonded and fully attached for the full 360° circumference (see figures 6.3-1 through 6.3-8). There were no areas of abnormal ablation. Small variations in ablation were noted which aligned with the rays in the motor grain. This phenomenon is also consistent with the performance for the secondarily bonded insulators.
